False Tract in PCNL Dilatation

• Akshay Nathani • Nishanth S • Arvind Ganpule

Torrential Bleed after Removal of Nephrostomy in Ward after PCNL

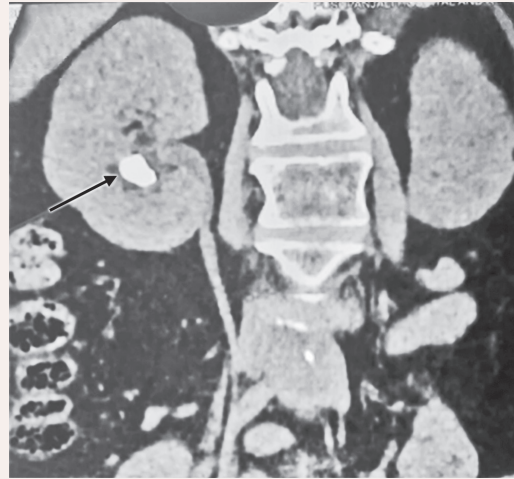
Fig. 2.1: Preoperative imaging

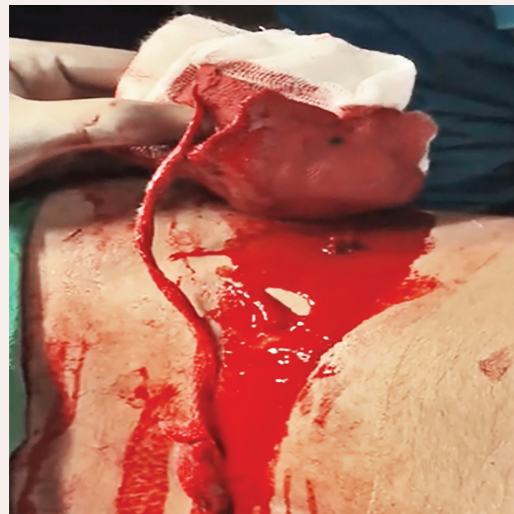
Fig. 2.3: Torrential bleeding from PCN site in ward

On Day 2, the PCN tube was removed in the ward. As shown in the video, torrential bleeding occurred from the nephrostomy site. The attending urologist applied manual compression, as illustrated in the accompanying picture. The color of urine in the per-urethral catheter was slightly red. The patient was stabilized with volume replacement.
